# ARBORICULTURAL REPORT AND SAFETY SURVEY

**Client:** Colwich Parish Council  
**Site:** Colwich Parish Centre  
Colwich Parish Allotments  
Colwich Jubilee Playing Fields

**Date:** 14 February 2019

**Ref.:** THL-R19-11

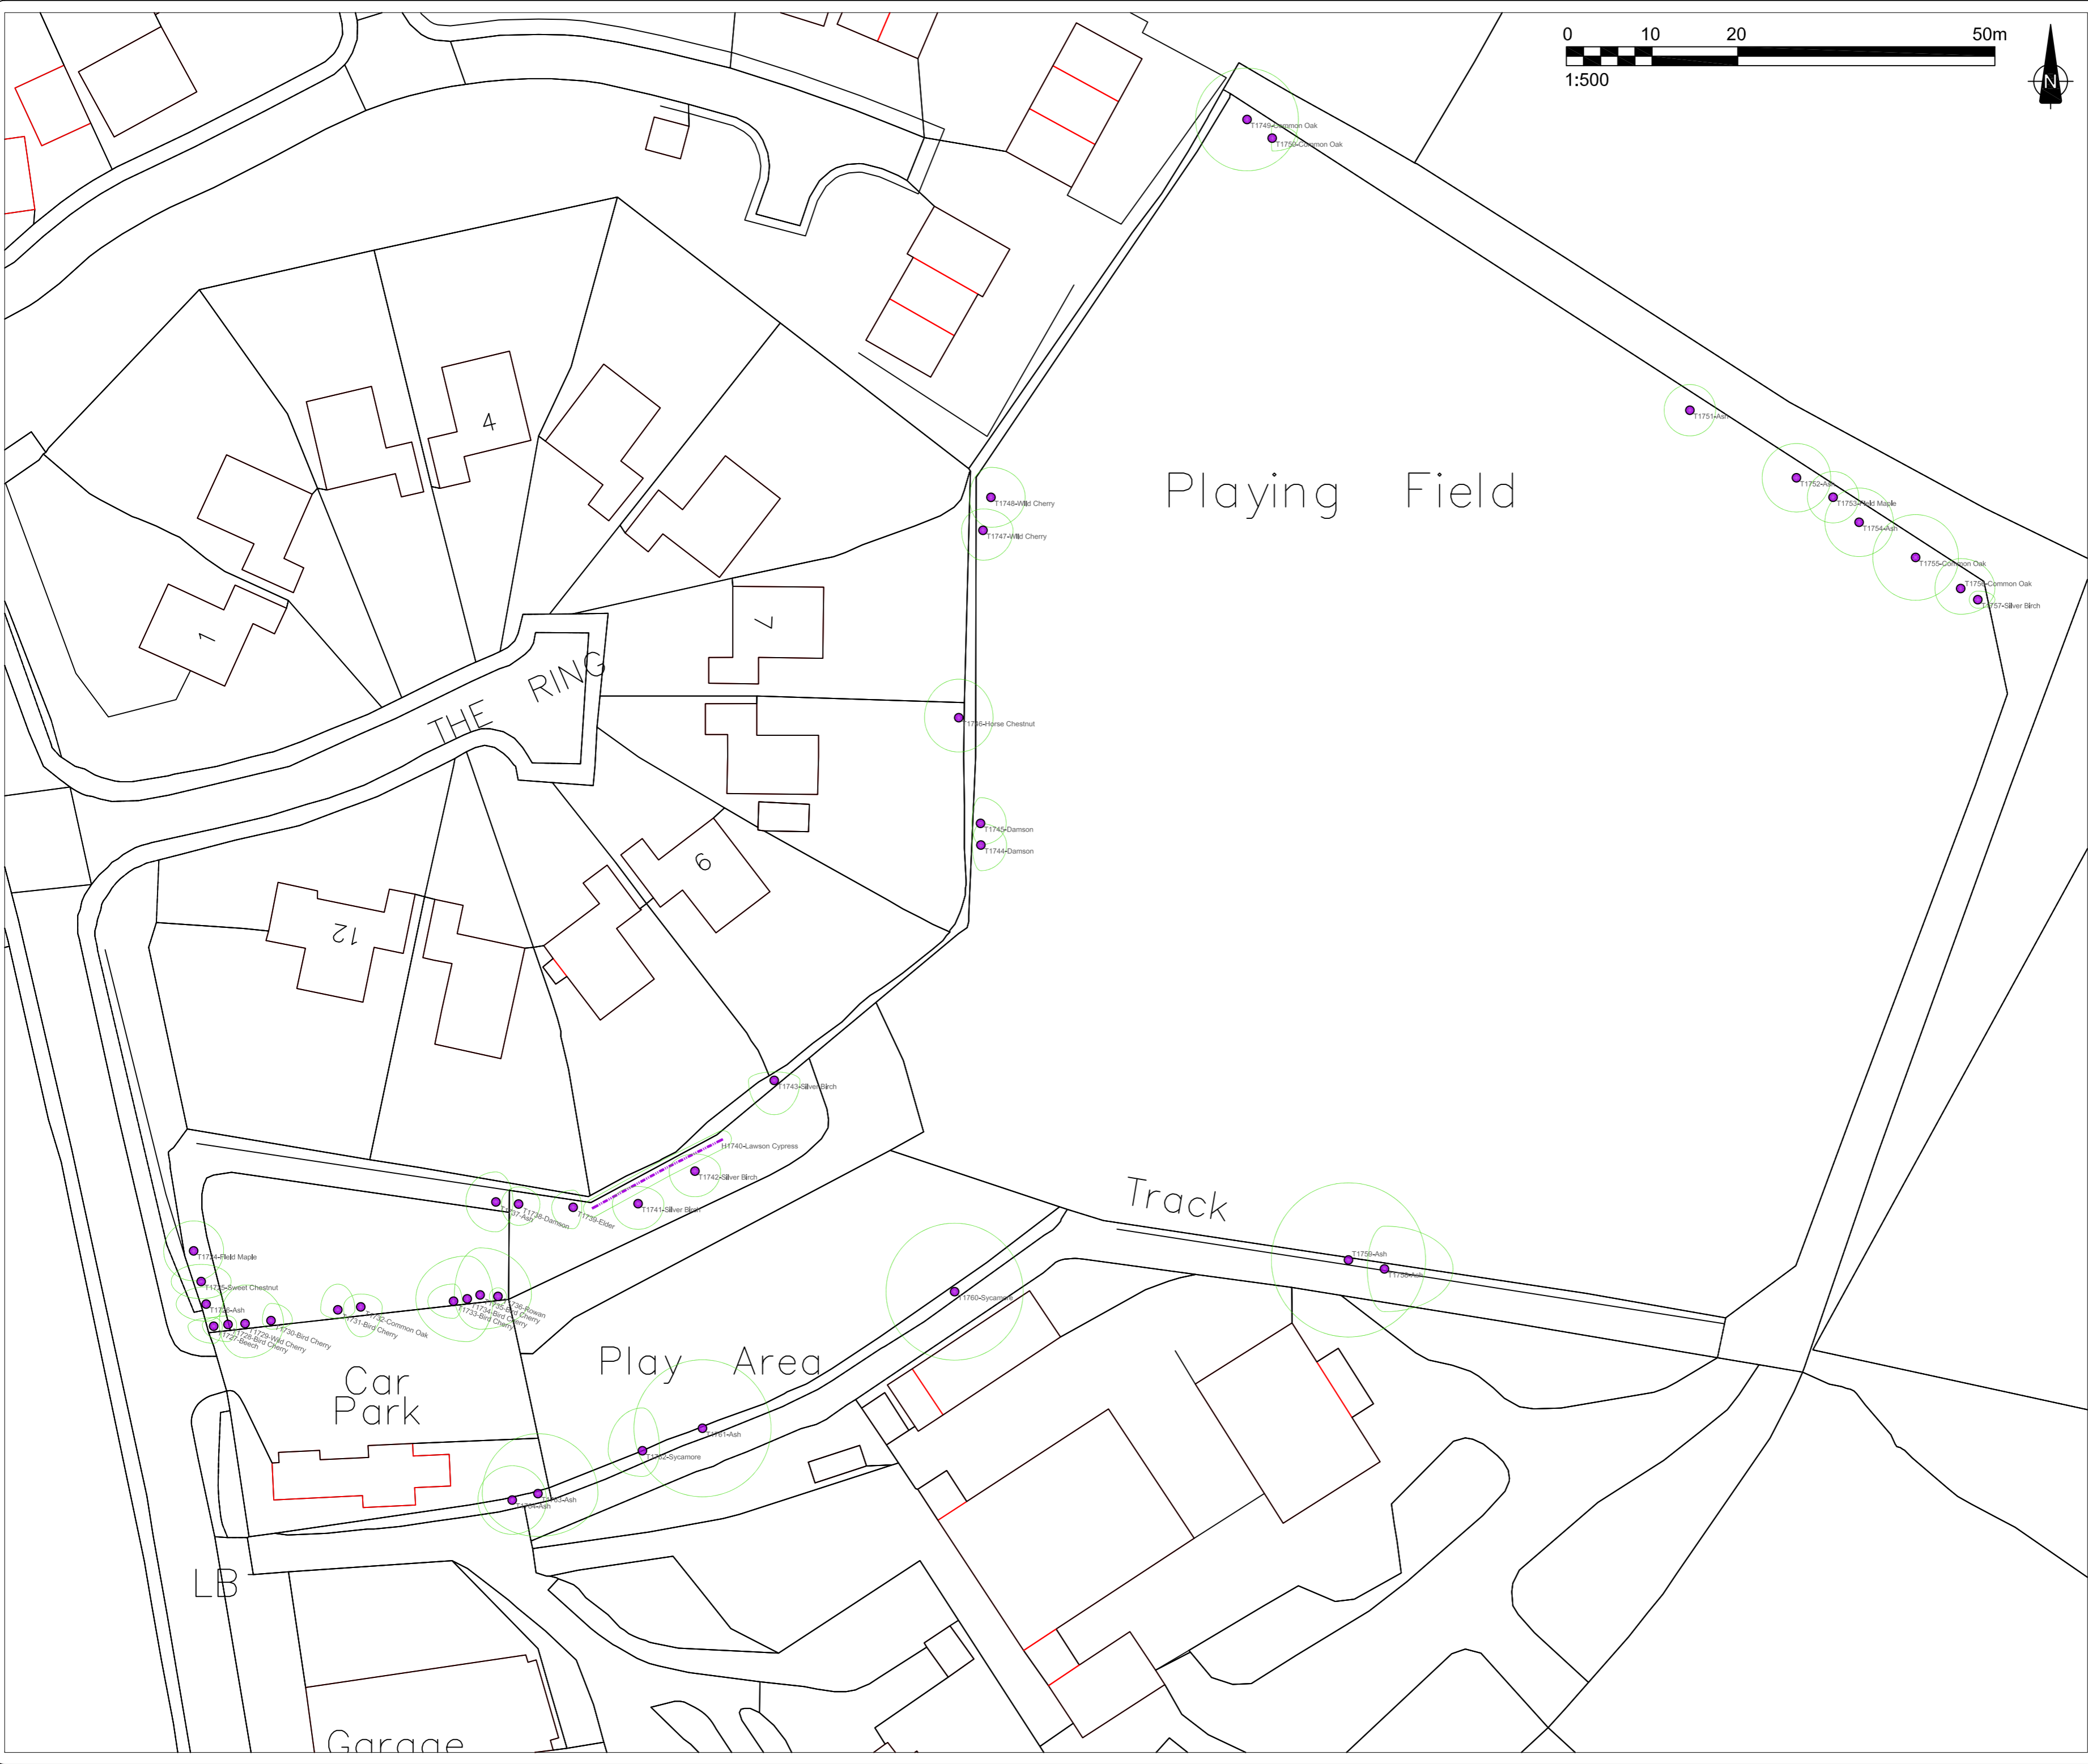
Scale: 1:500	Paper Size: A2
Drawing Number: THL-0734-1	Date Created: 12/02/19

7.2 A total of 40 individual trees and 1 hedgerow were included in the survey. All trees and hedges are listed in the schedule and shown on plan THL-0734-1 attached to this report.

7.3 Most of the trees on site are in fair to good condition and only require basic maintenance such as crown lifting and removal of deadwood. Specific recommendations, and an indication of timescale, for each individual tree is included in the tree schedule.

7.4 Several of the trees are covered in ivy making inspection of the base and stem difficult. Some of these trees are located just beyond the boundary on neighbouring land. It is recommended that the ivy is severed at the base making re-inspection easier. For further details please see the tree survey schedule attached.

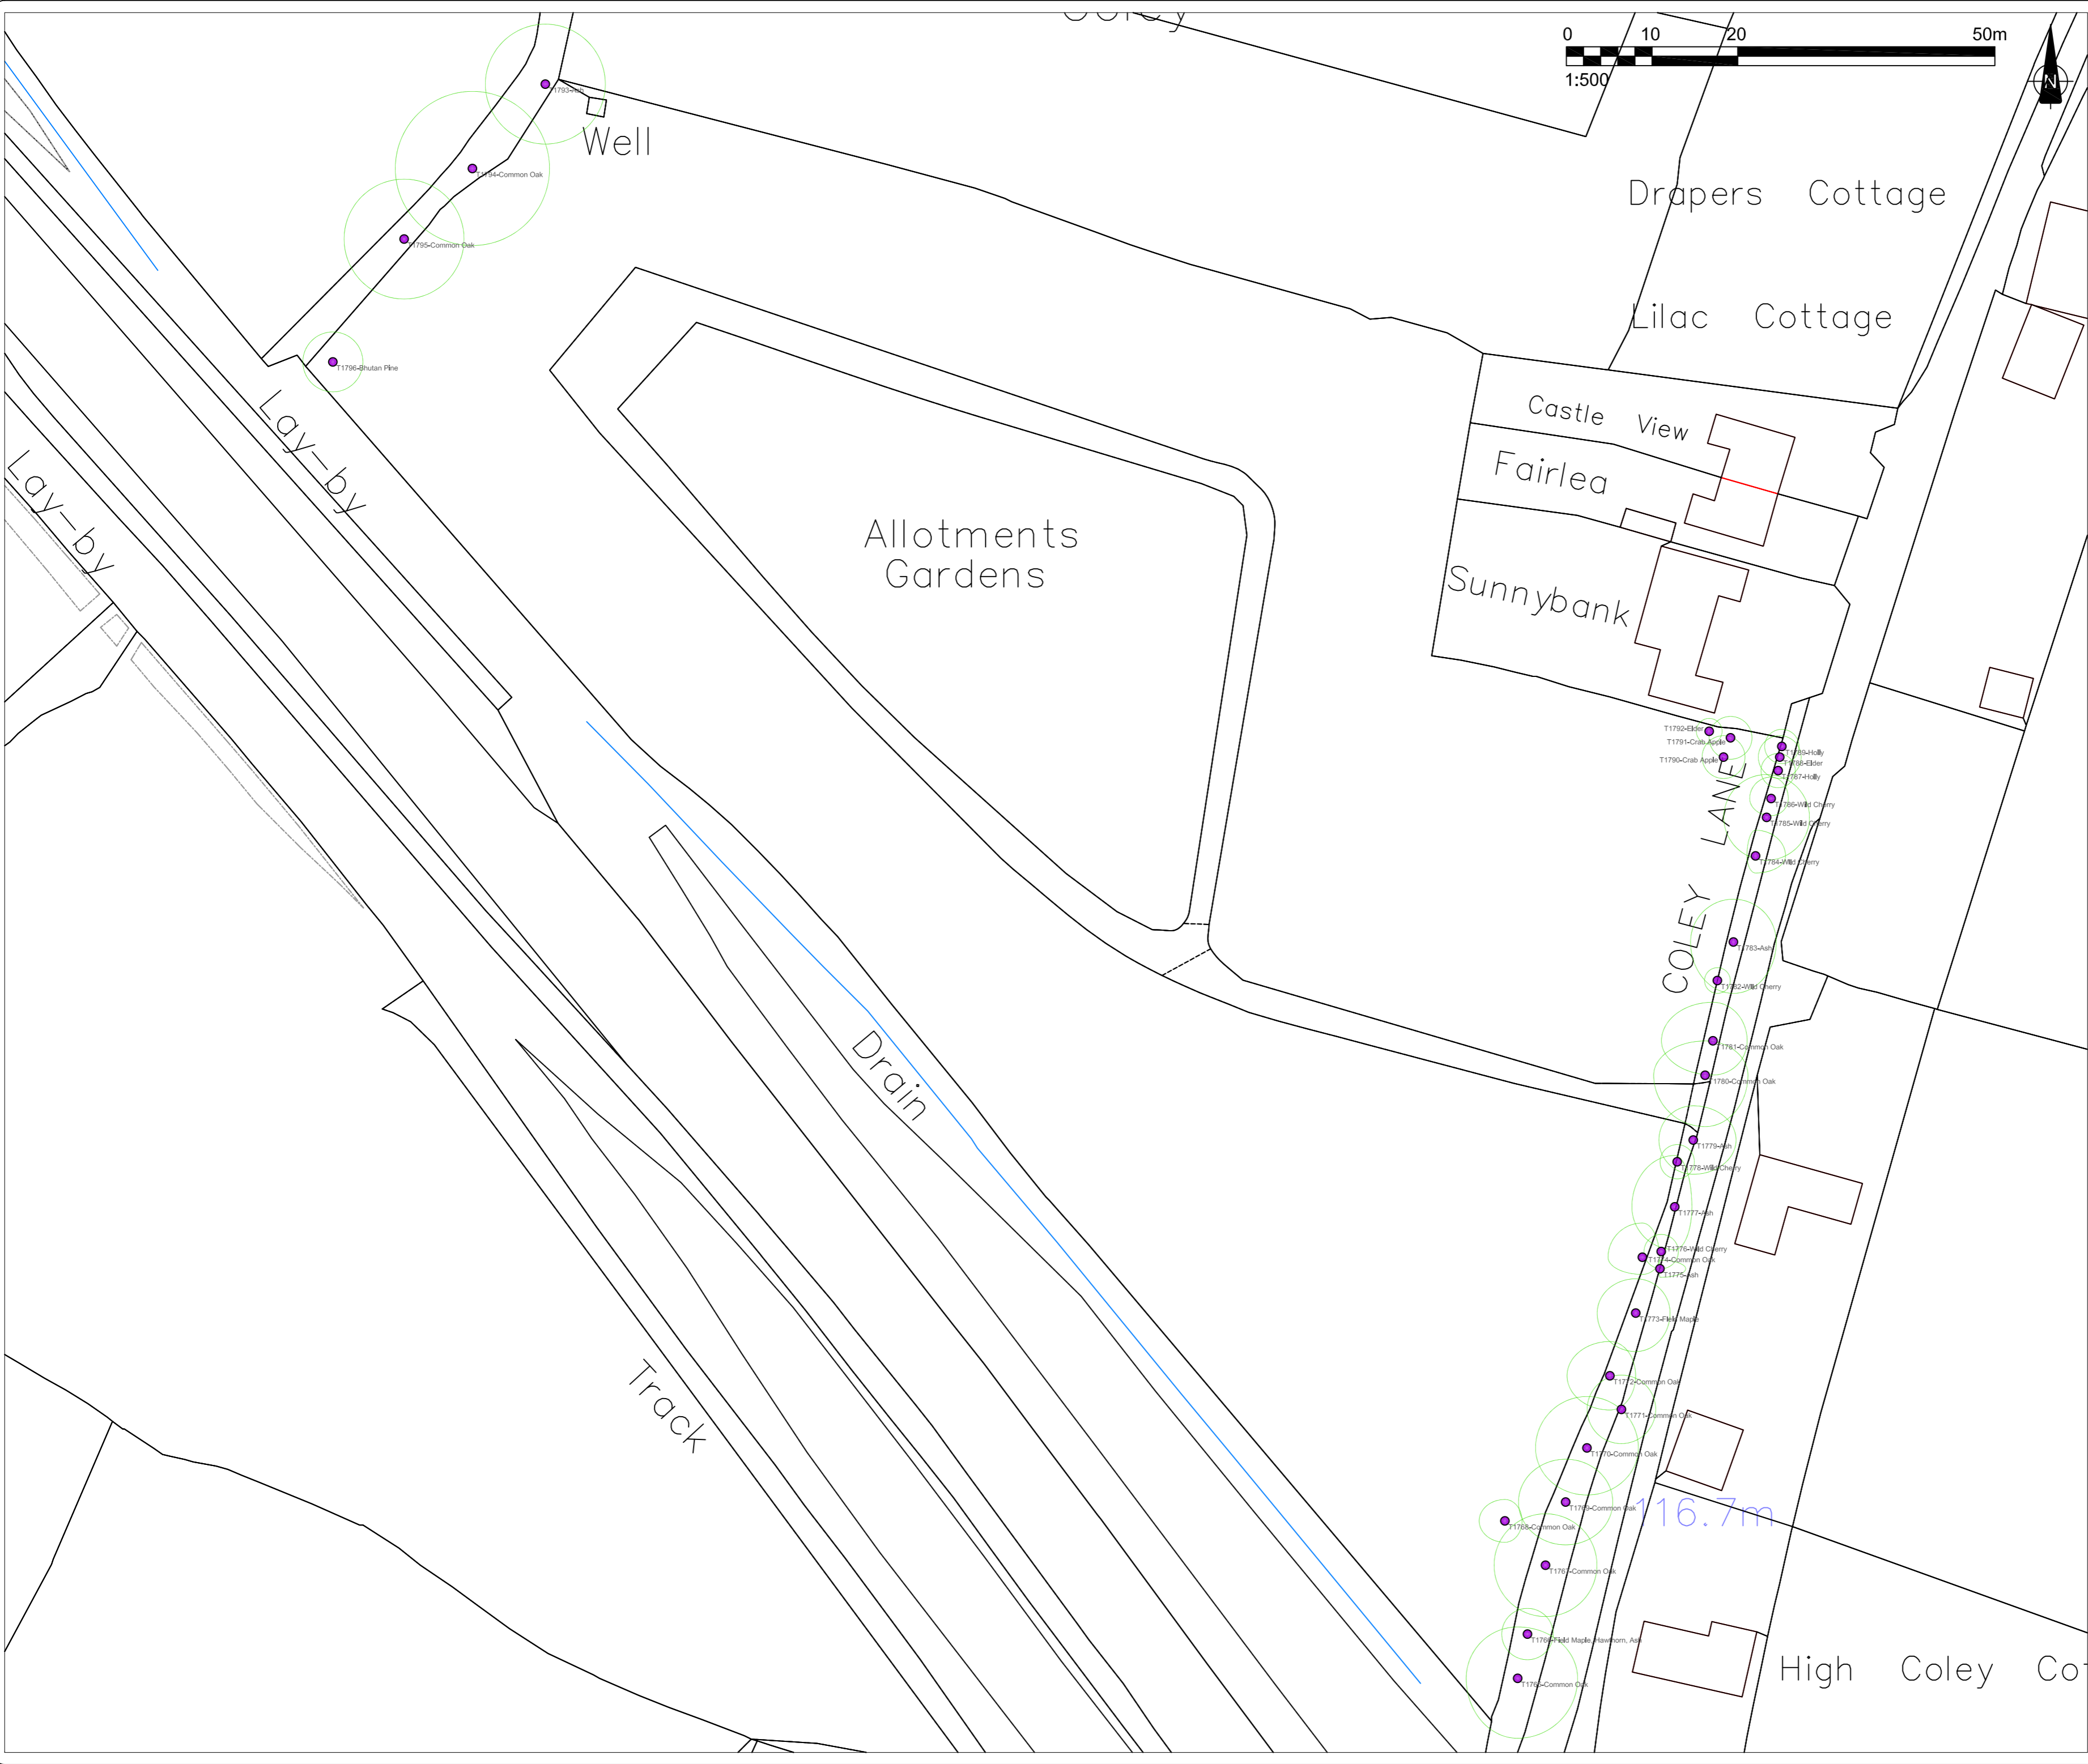
<b>Scale:</b> 1:500	<b>Paper Size:</b> A2
<b>Drawing Number:</b> THL-0734-2	<b>Date Created:</b> 12/02/19

7.6 A total of 32 trees were included in the survey. All trees are listed in the survey schedule and shown on plan THL-0734-2 attached to this report.

7.7 All the mature trees located adjacent to the Coley Lane, and the mature trees located at the far end of the site, were individually tagged. The smaller trees located within the individual allotments were inspected, but not tagged due to their small size and risk of damaging the stems.

7.8 As with the playing field site, the work on this site is mainly deadwood removal and severing ivy.

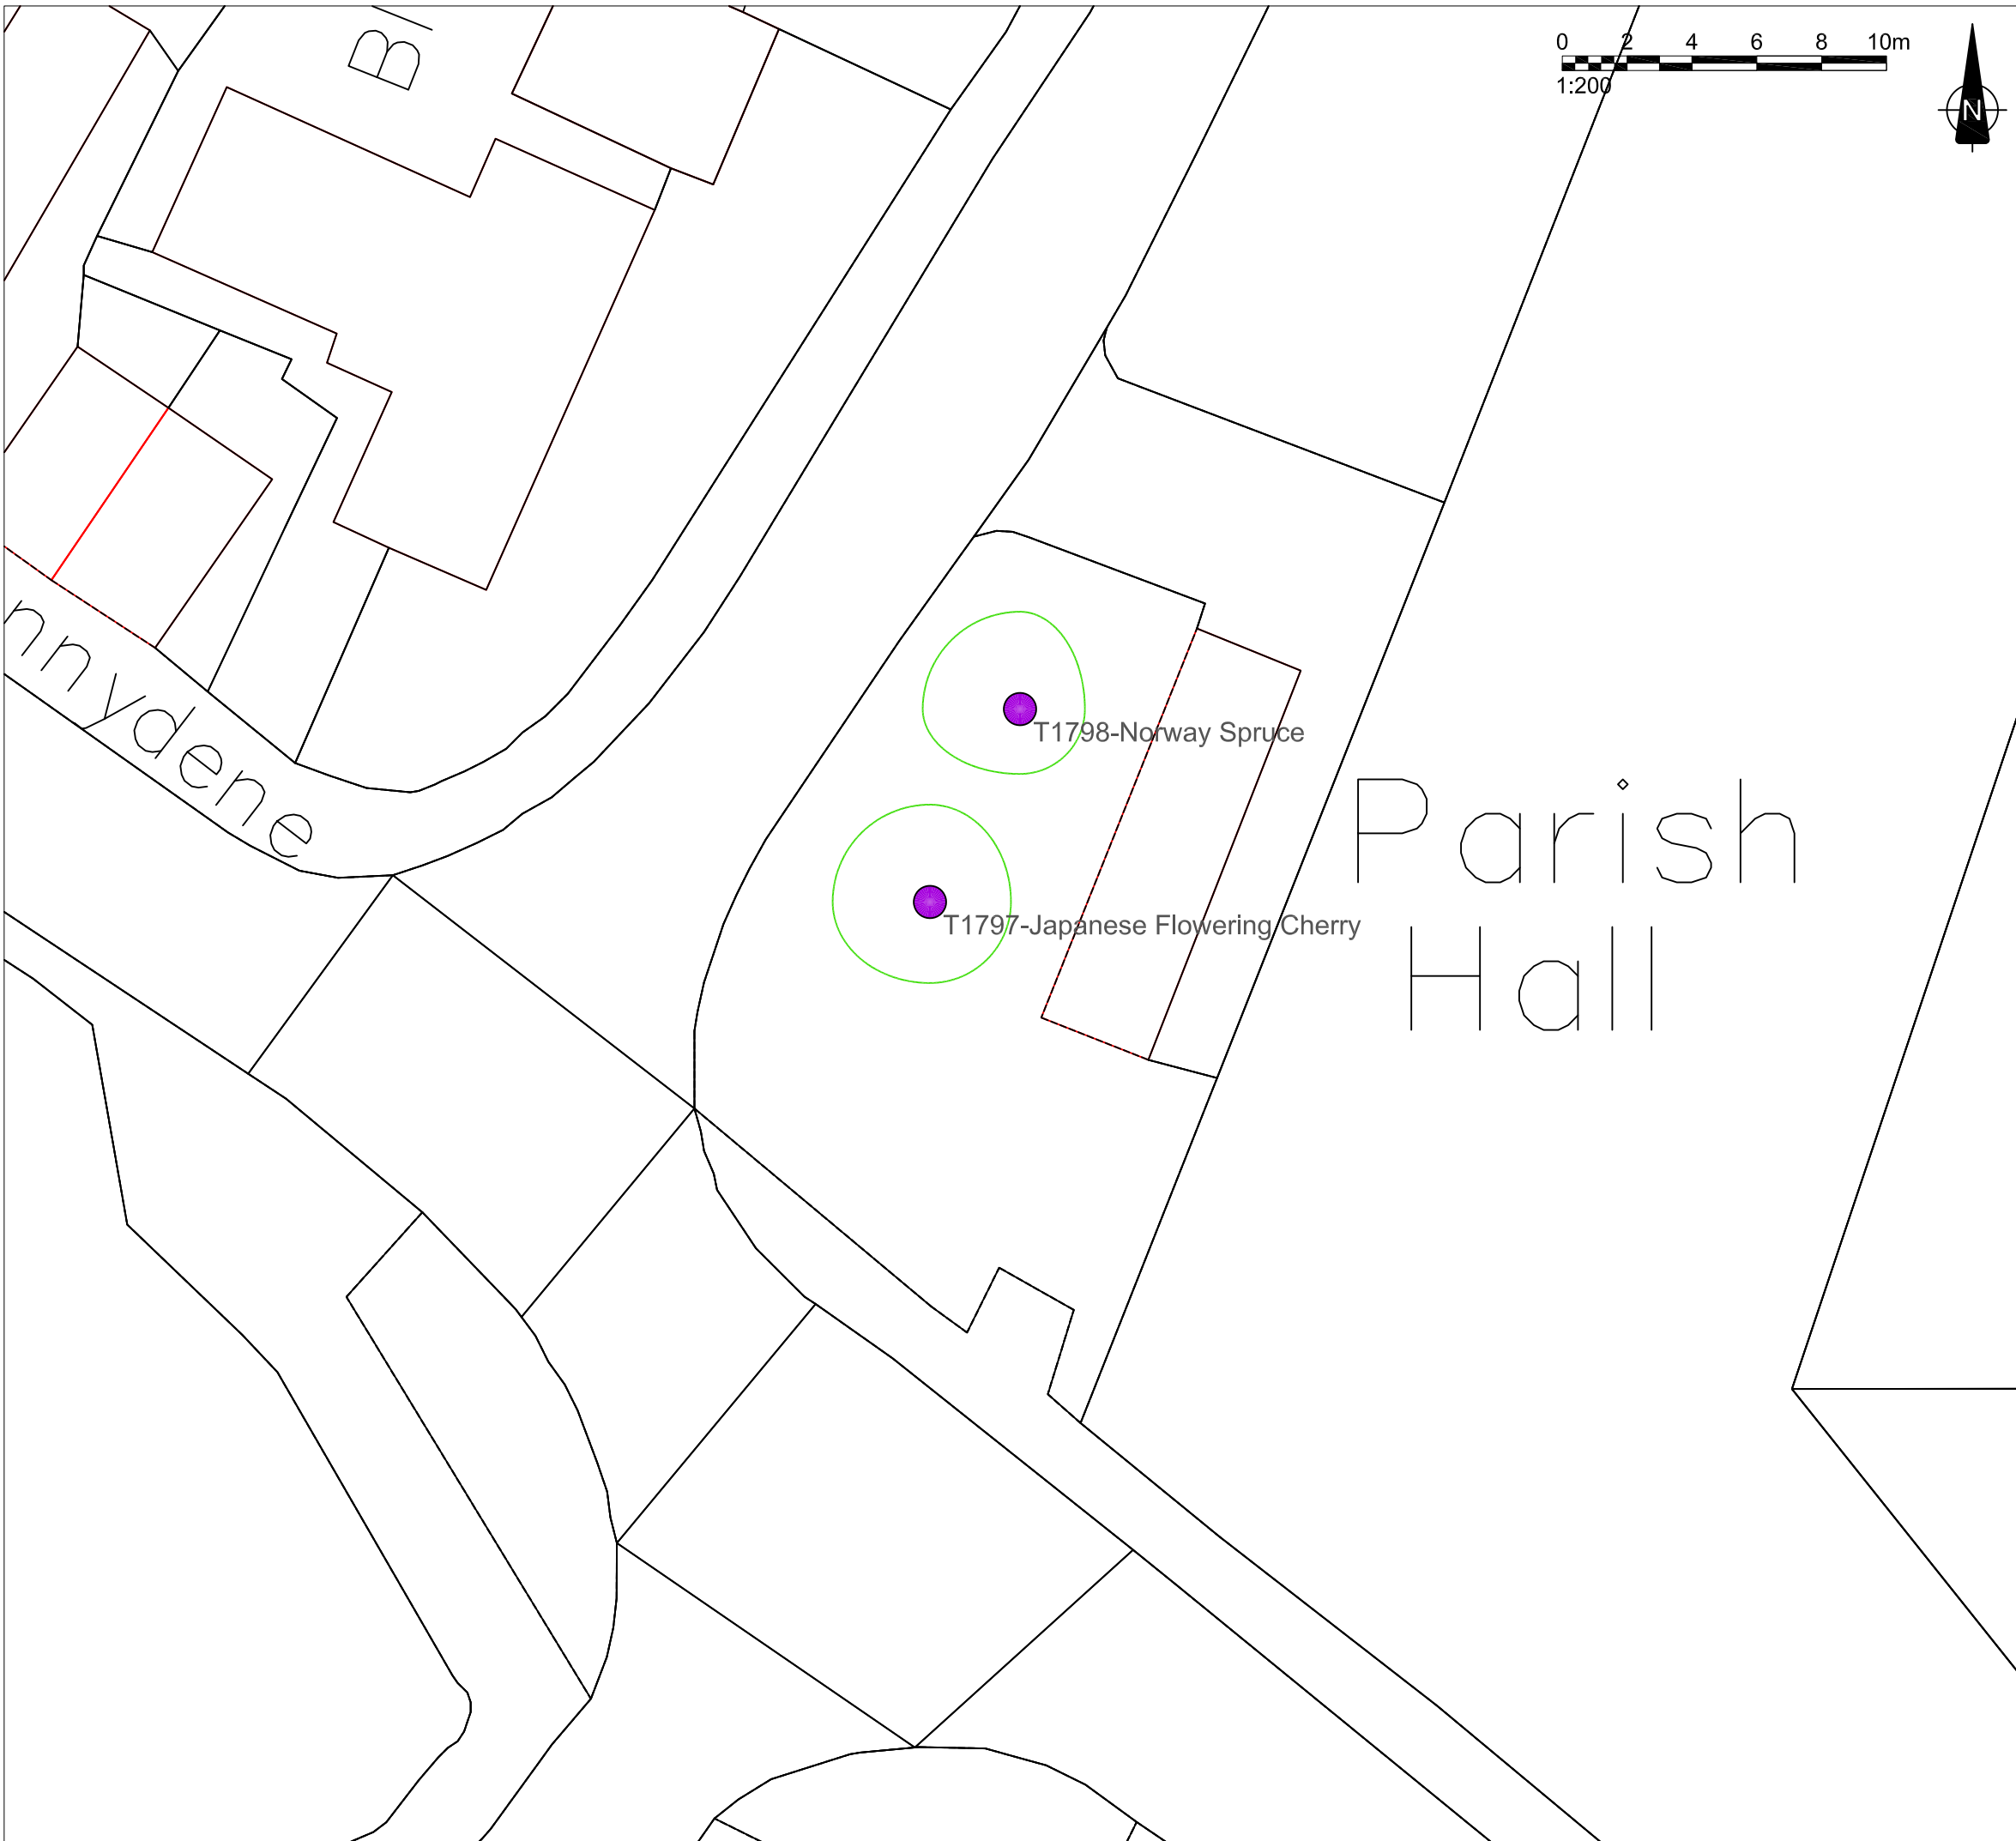
<i>Scale:</i>	1:200	<i>Paper Size:</i>	A3
<i>Drawing Number:</i>	THL-0734-3	<i>Date Created:</i>	12/02/19

7.10 A total of 2 trees were included in the survey of this site. The trees are listed in the schedule and shown on plan THL-0734-3.

7.11 No work is required on this site at this stage.
